# THE VANGUARD SATELLITE LAUNCHING VEHICLE - AN ENGINEERING SUMMARY \*

(Engineering Report No. 11022)

April 1960

THE MARTIN COMPANY, Baltimore, Md.

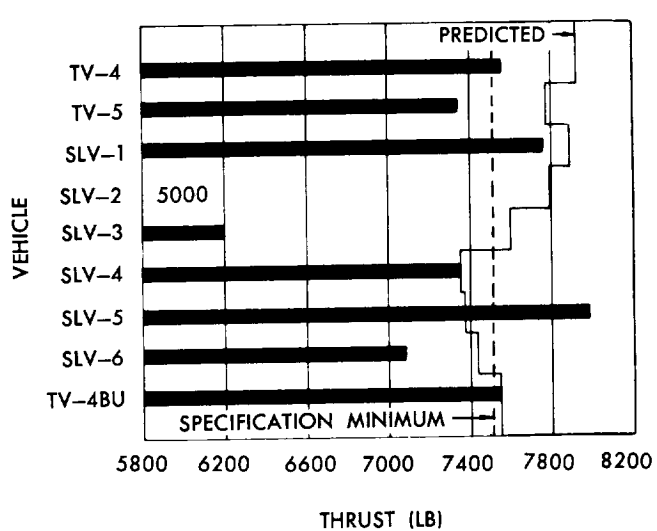
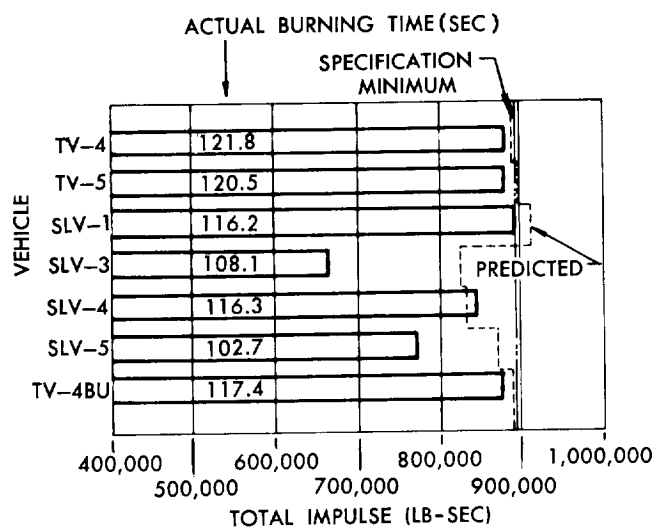
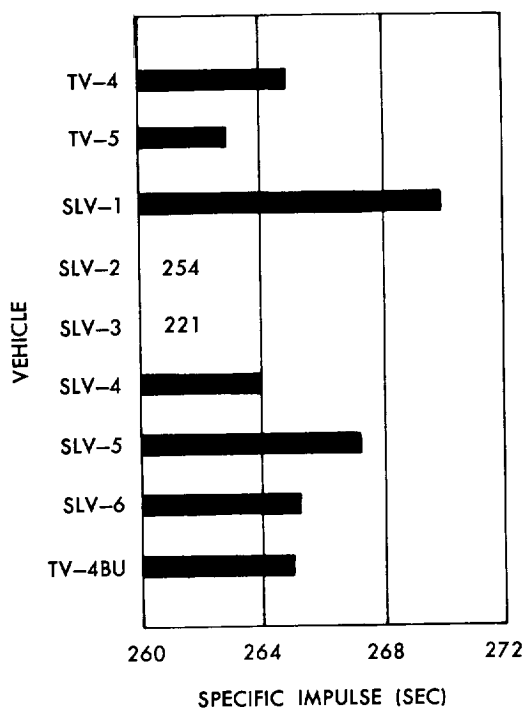
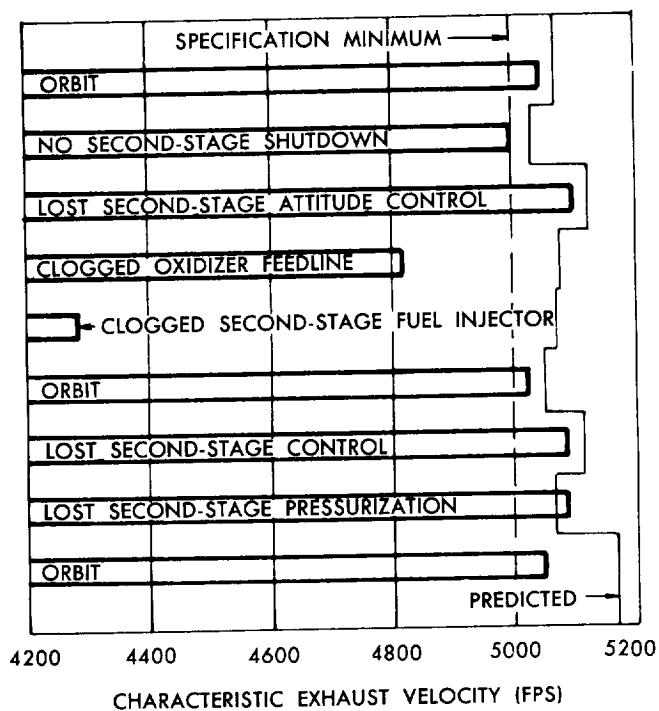
Fig. 60 Second-Stage Performance Parameters

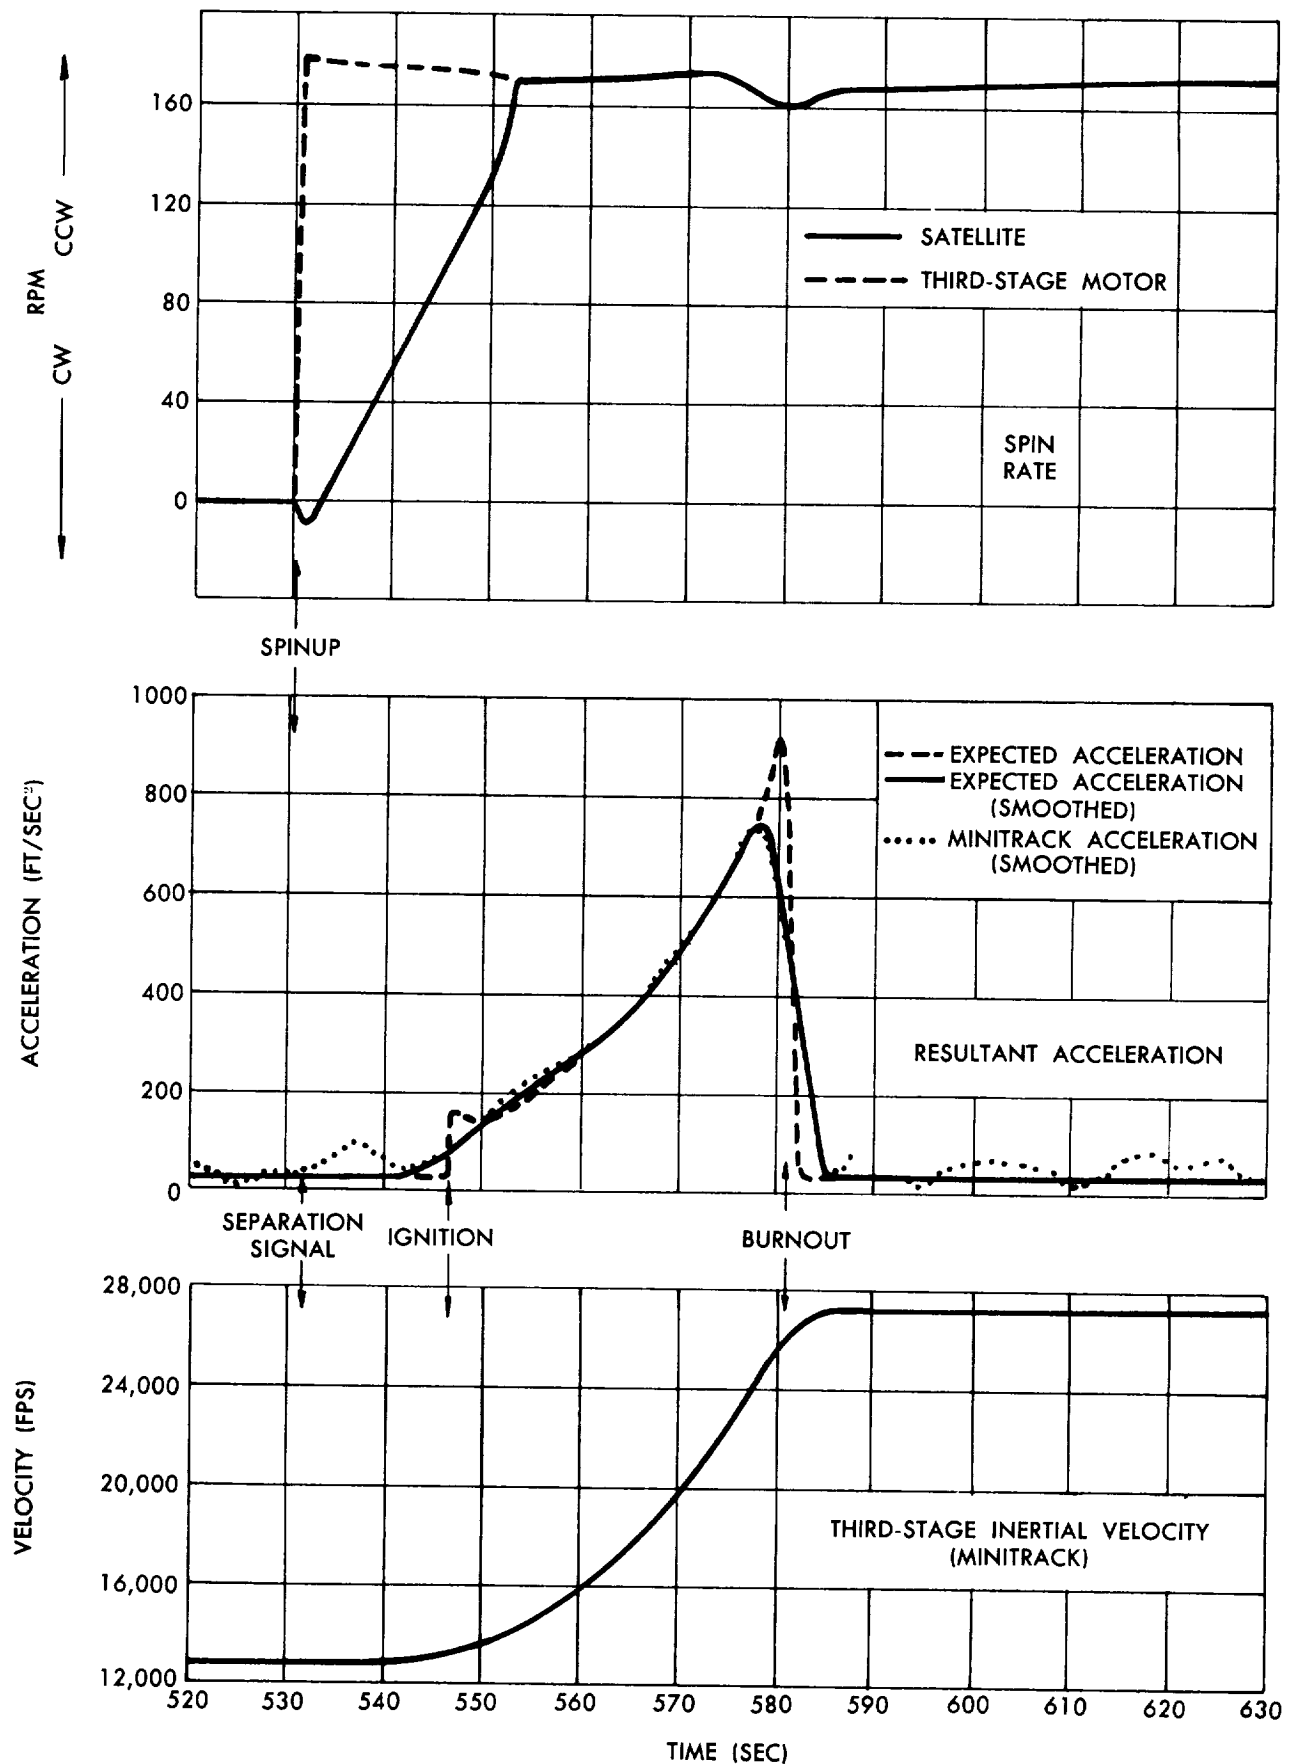
Fig. 61 Time Histories of Velocity, Acceleration and Satellite Spin Rate During Third-Stage Powered Flight, TV-4BU.

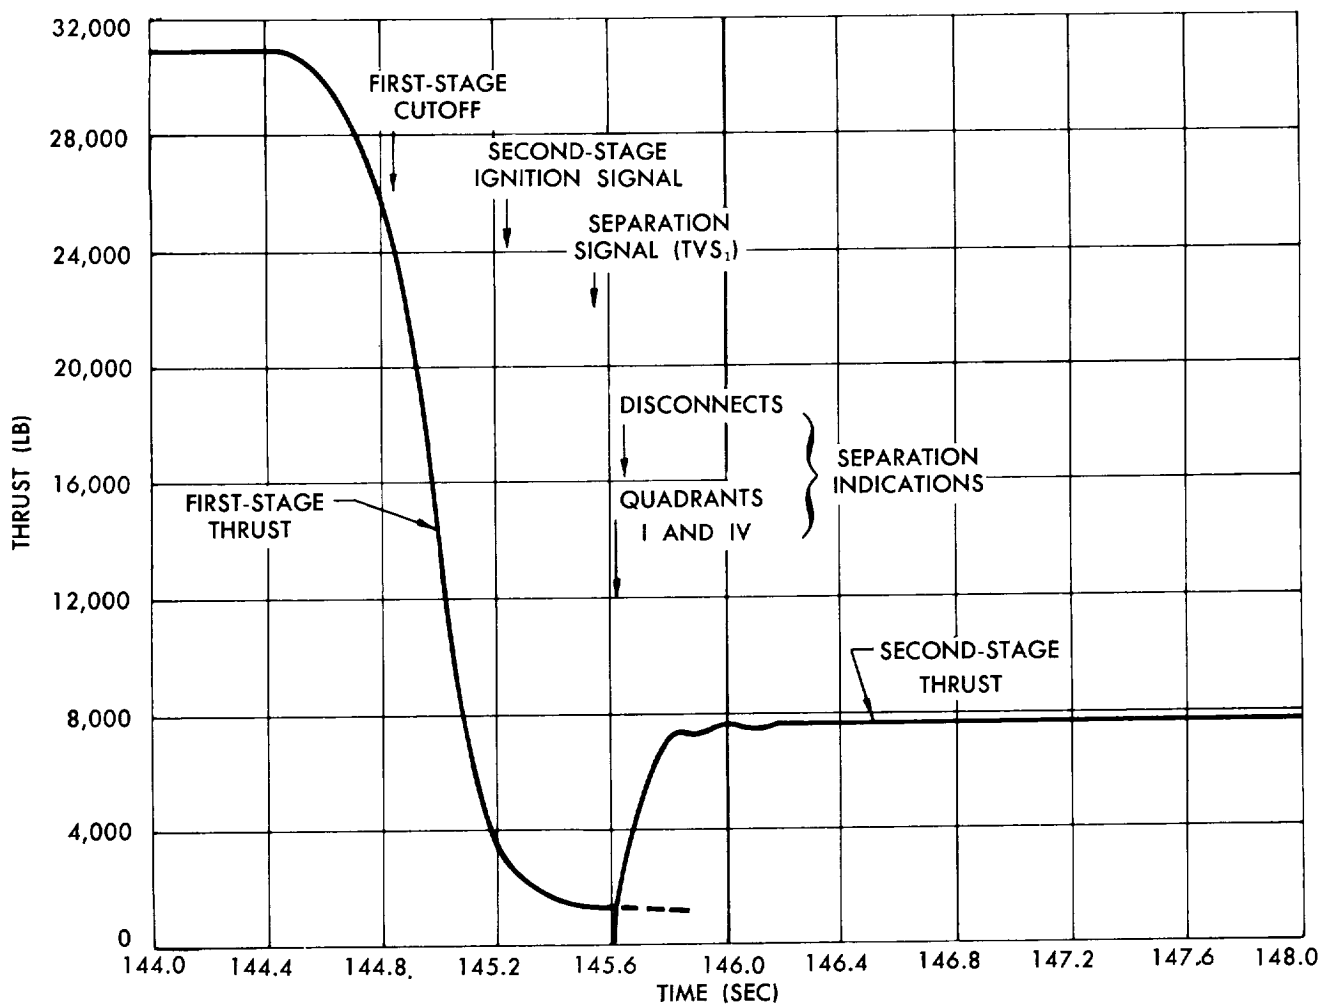
Fig. 62 Representative (TV-4BU) First and Second-Stage Thrust During First-Stage Separation

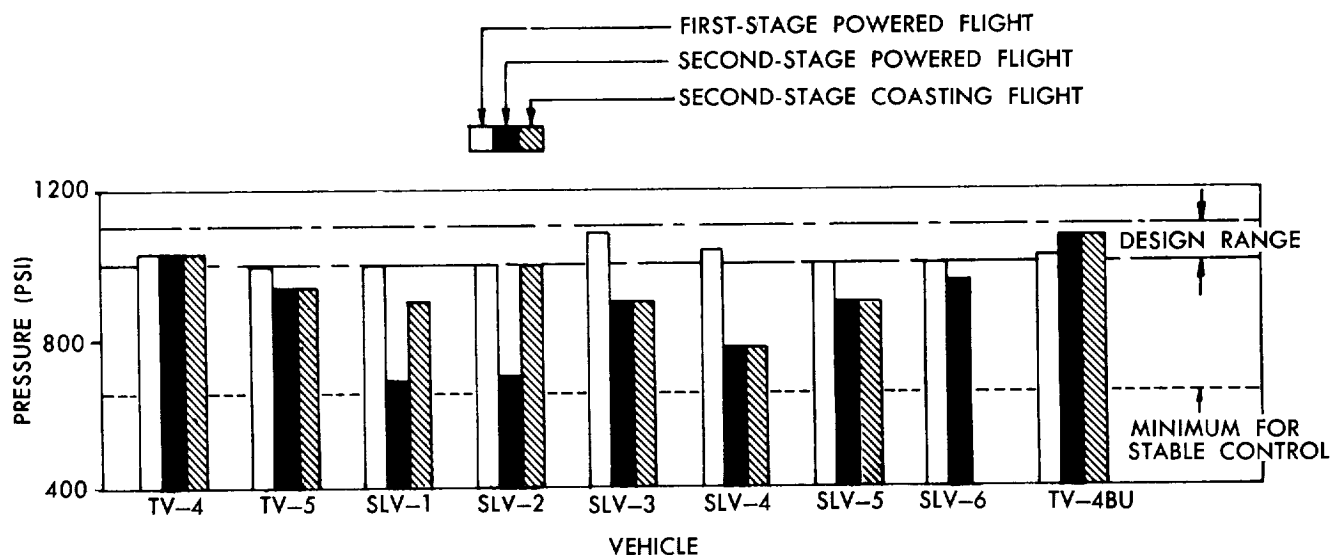
Fig. 63 Average Steady-State Second-Stage Hydraulic Pressure

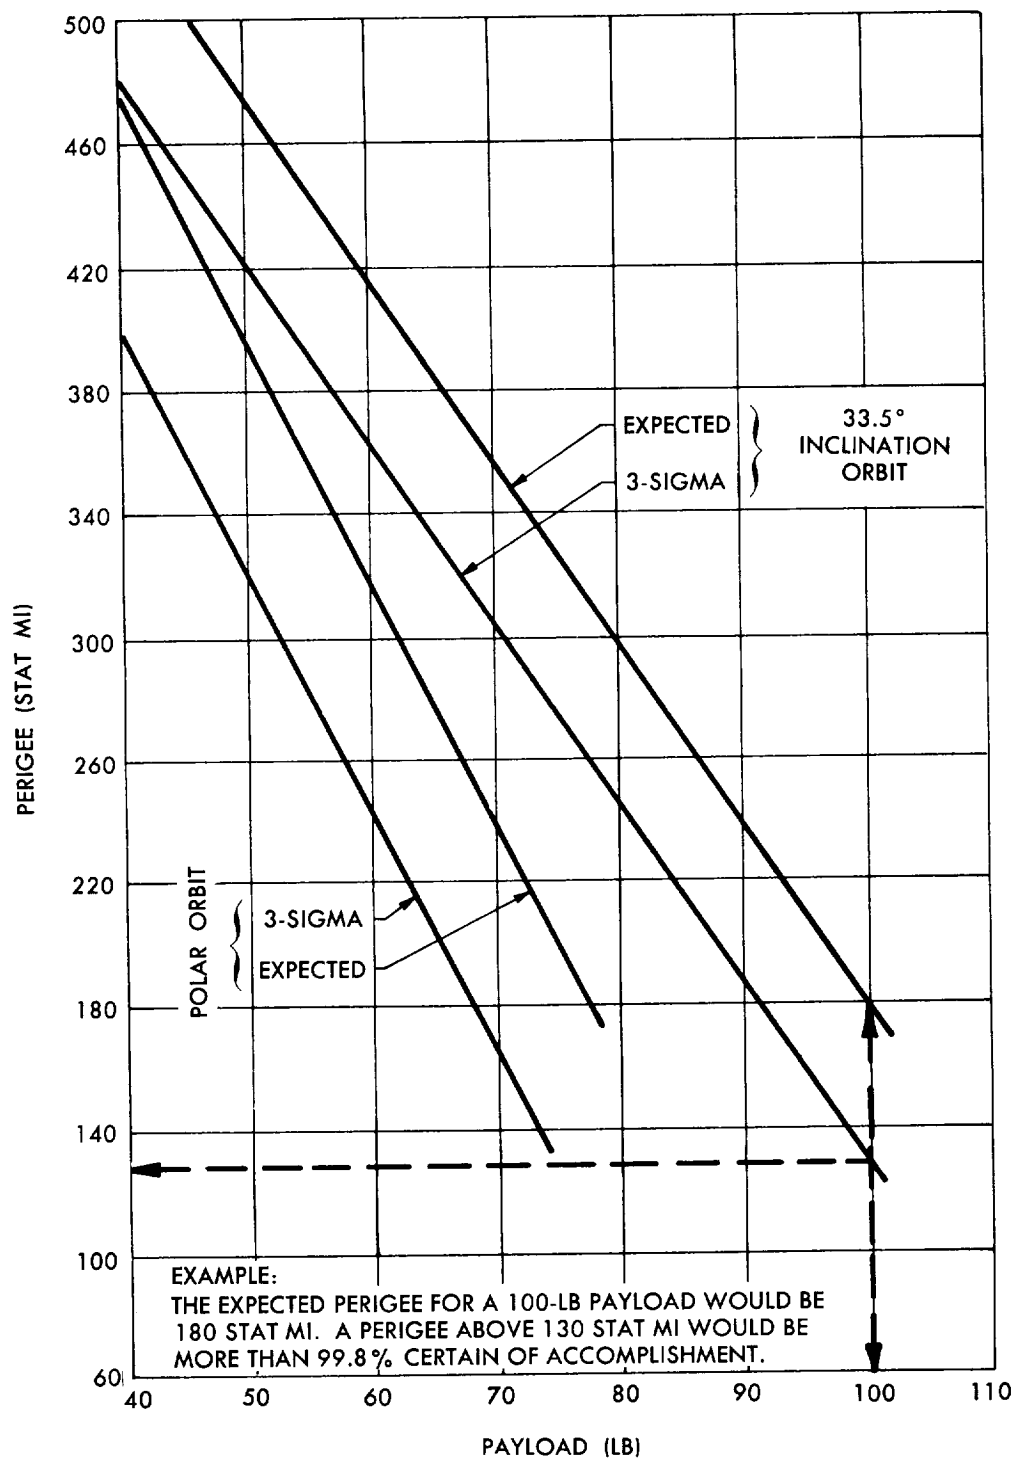
Fig. 64 Payload Capability for Orbital Missions, Using Optimized Flight Programs

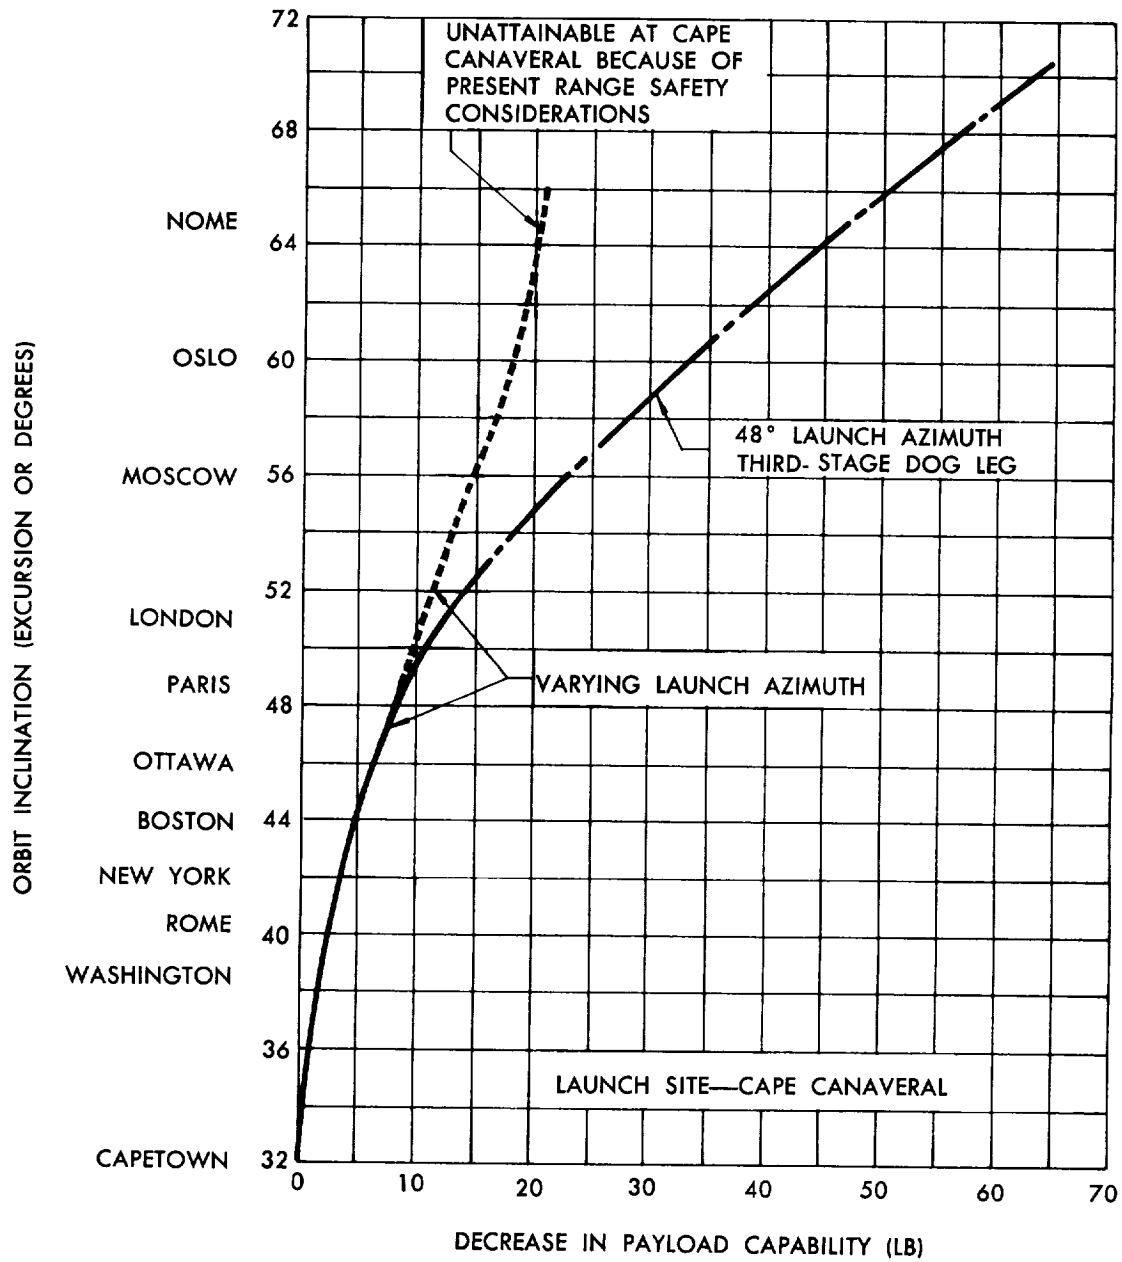
Fig. 65 Approximate Decrease in Payload Capability for Increasing Orbit Inclination

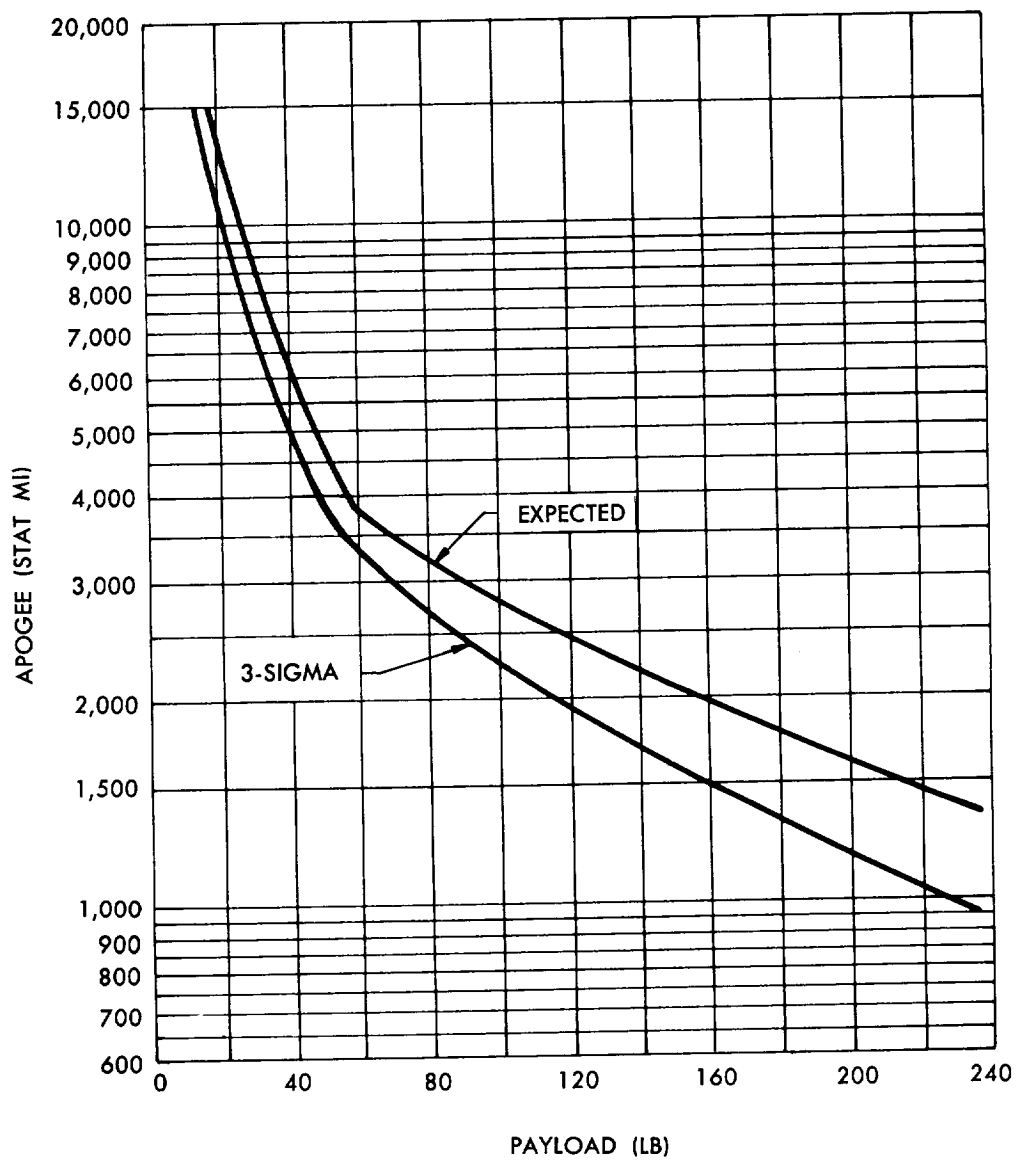
Fig. 66 Vanguard Payload Capability for Space Probe Missions

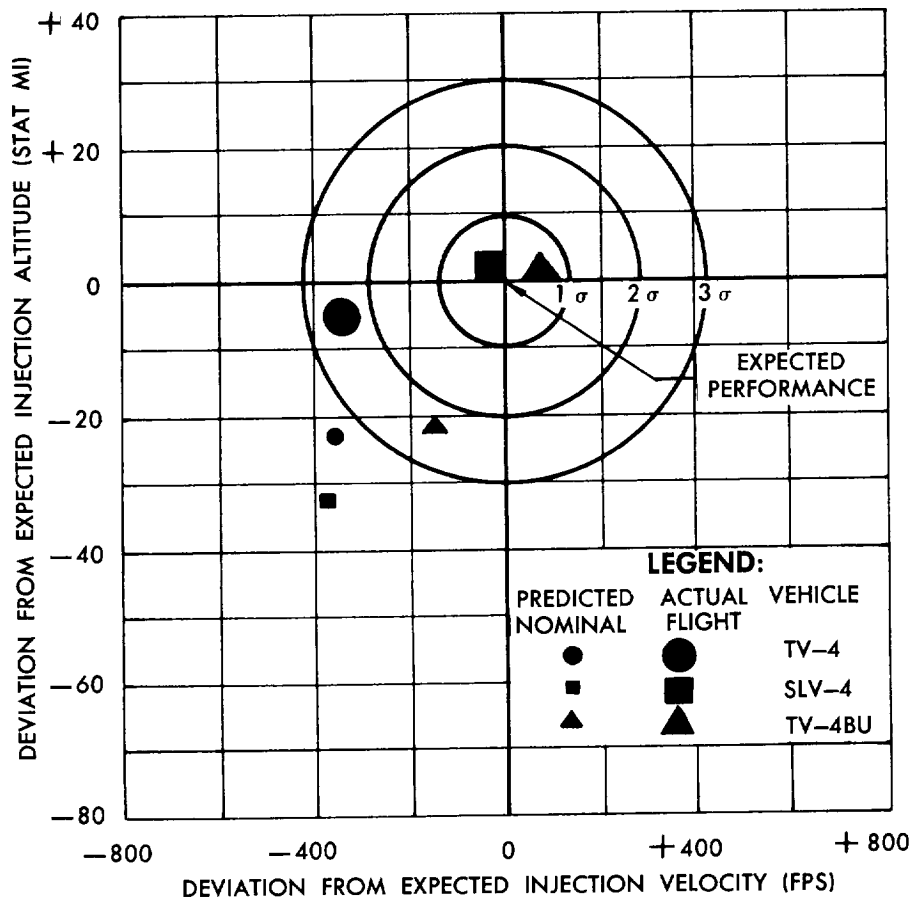
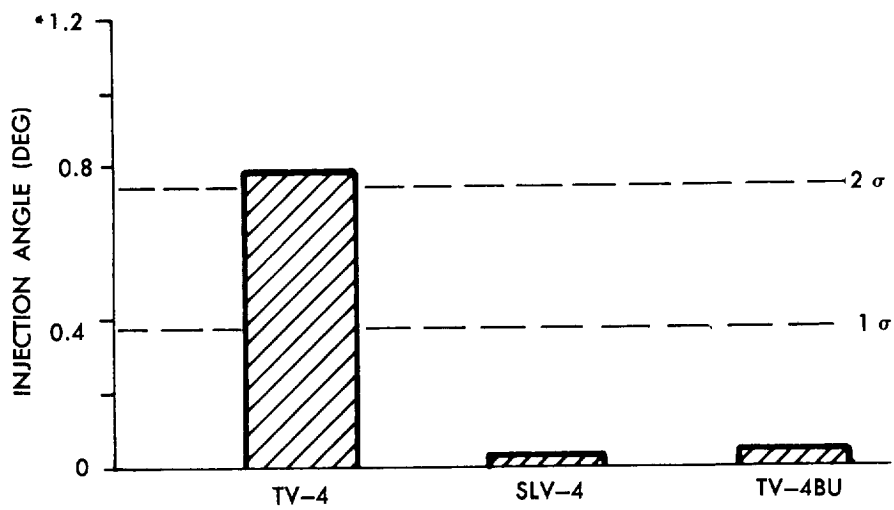
Fig. A-2 Comparison of Orbit Injection Conditions
